United States Environmental Protection Agency
Washington, D.C. 20460
Water Compliance Inspection Report

**SUPPLEMENT TO WATER COMPLIANCE INSPECTION REPORT FORM
(EPA FORM 3560-3 (REV 9-94))**

Webb Street Sanitary Sewer System

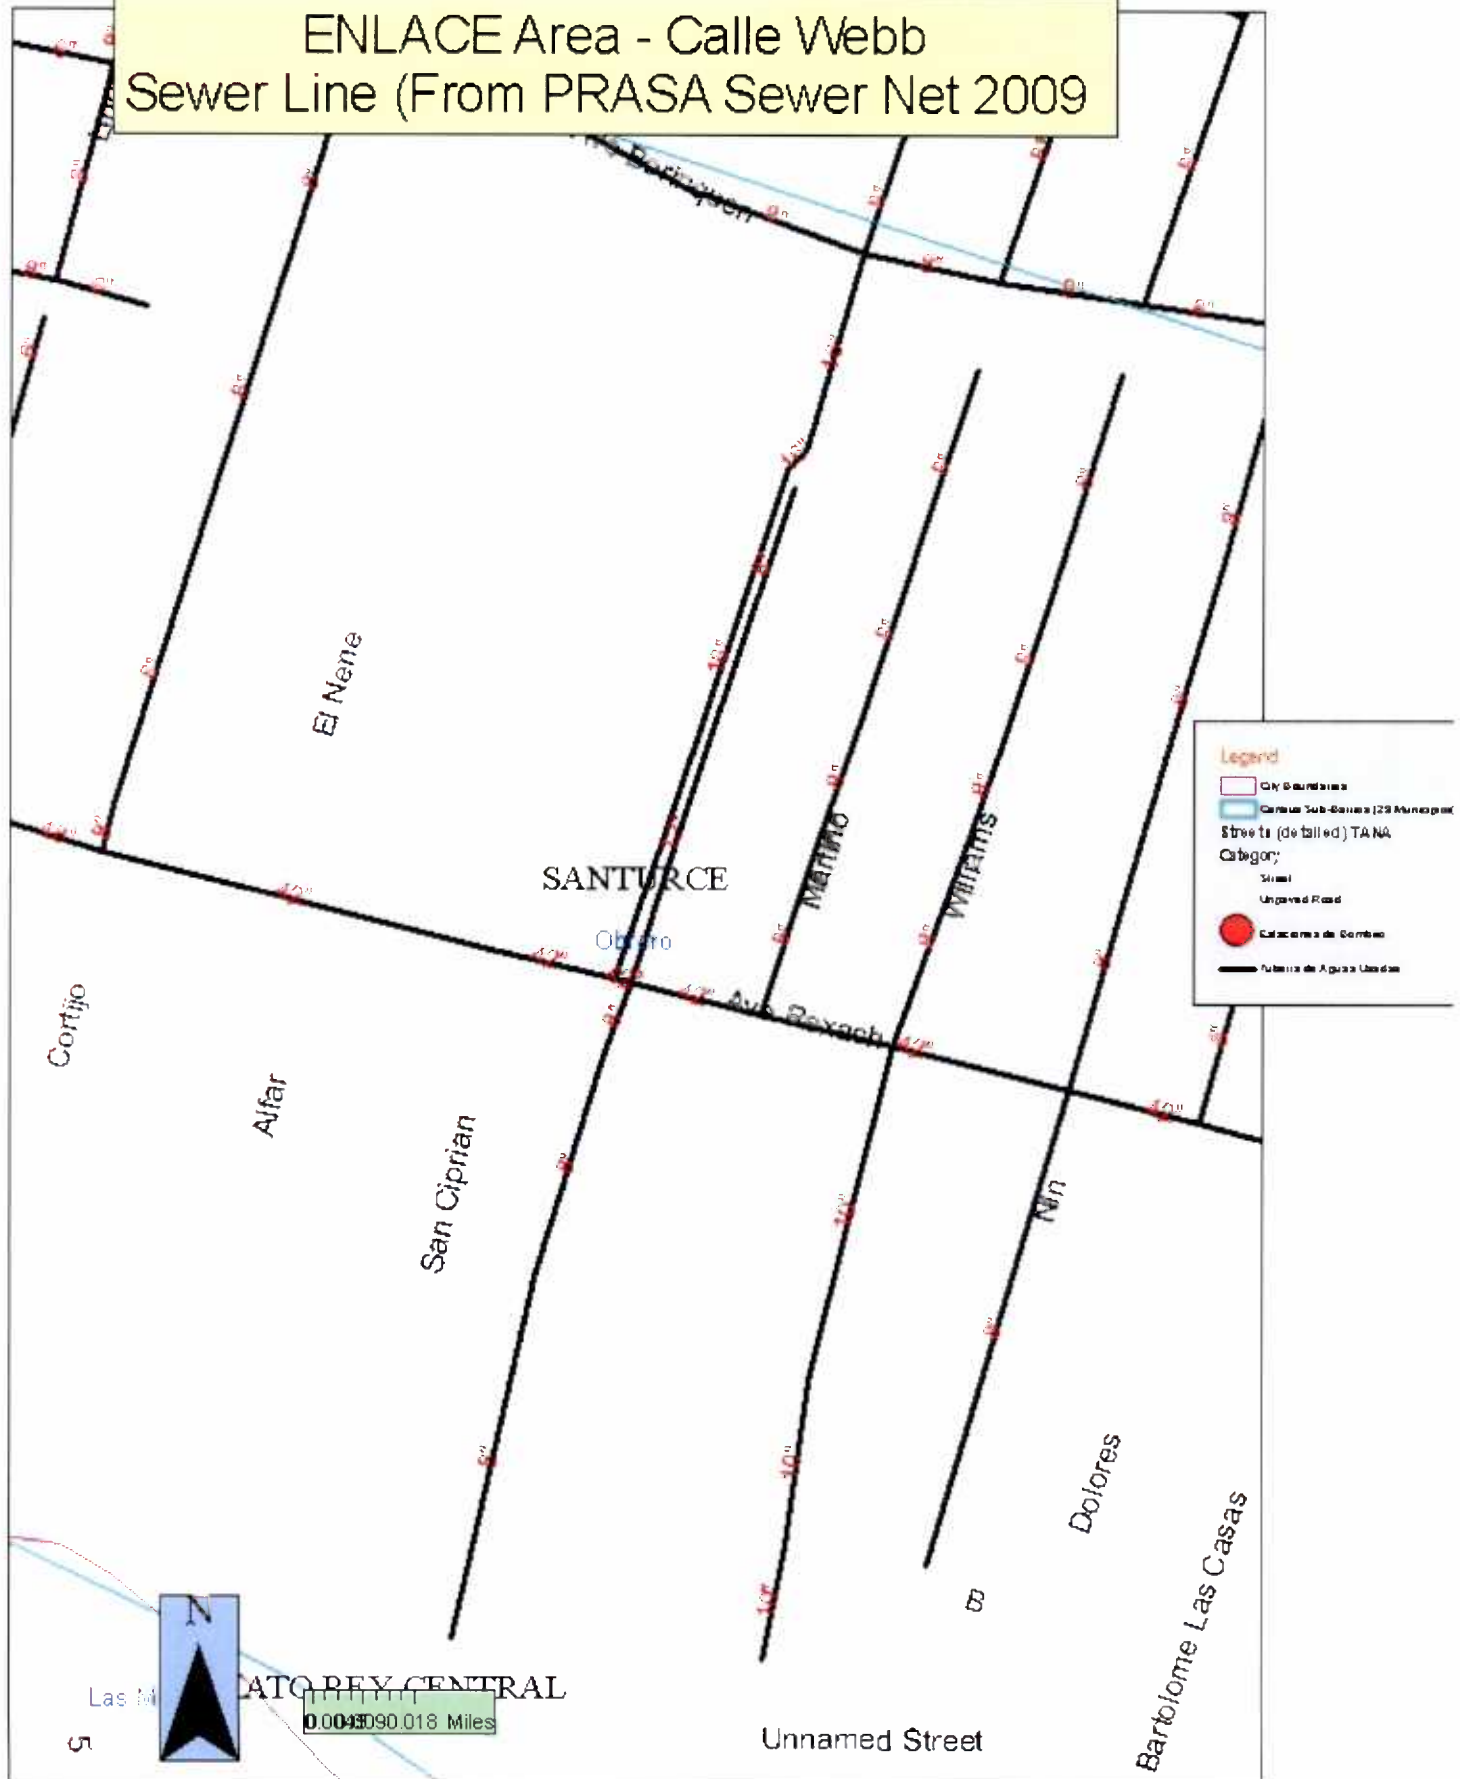
ENLACE Area - Calle Webb Sewer Line (From PRASA Sewer Net 2009)

- 1) The Webb Street SSS is owned and operated by the Puerto Rico Aqueduct and Sewer Authority ("PRASA"). It consists of an eight-inch in diameter sanitary sewer pipeline. See attached Map (ENLACE Area – Calle Webb Sewer Line from PRASA Sewer Net 2009).

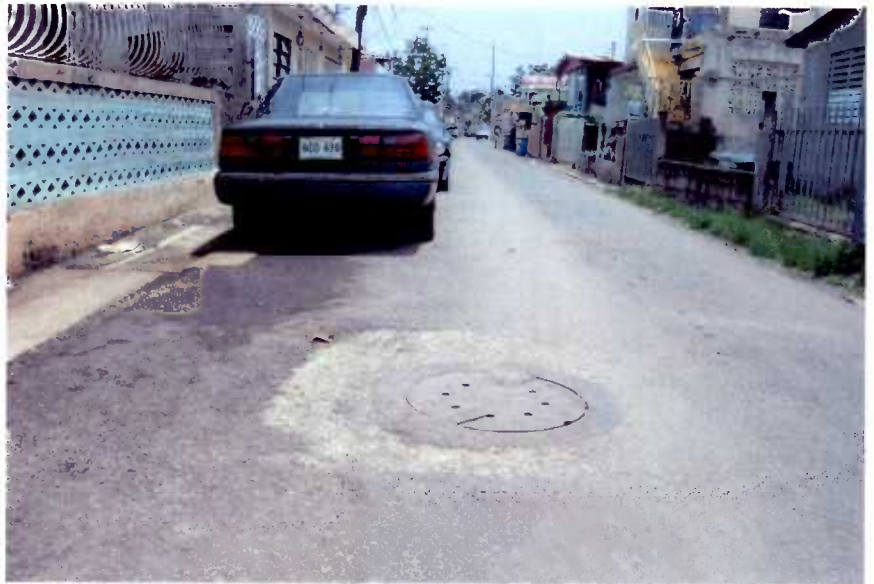
- 2) The Webb Street SSS is located south of the Rexach Avenue, Barrio Obrero Subward, Santurce Ward in San Juan, Puerto Rico. See attached Photo No. 1.

Photo No. 1. View of a manhole and cover of the Webb Street Sanitary Sewer System.

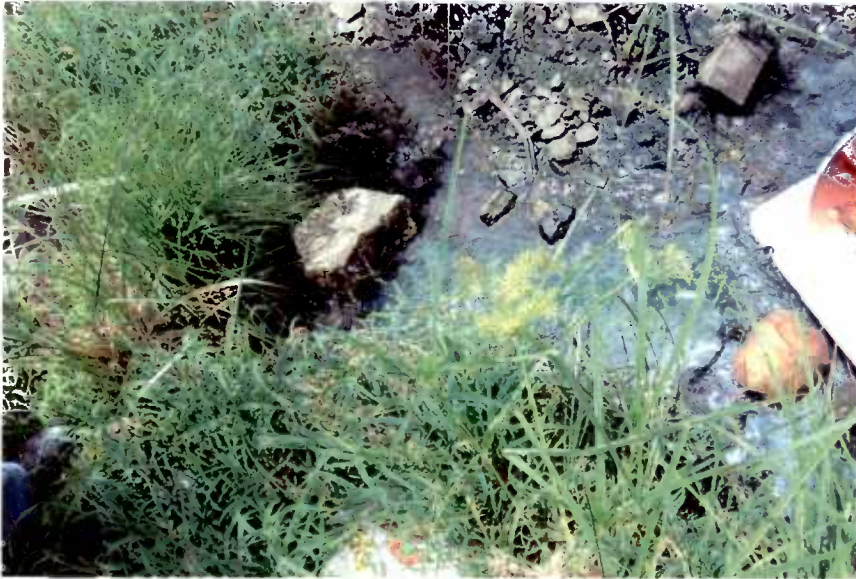
- 5) The Webb Street SSS runs downhill on Webb Street and does not connect to any other sanitary sewer pipeline at its end near the Martin Peña Channel. The Webb Street SSS 8-inch diameter pipeline ends at a 12-inch concrete culvert, which discharges into a manmade channel (e.g., ditch), which in turns discharges into the Martin Peña Channel. See attached Photo No.2.

Photo No. 2. View of the Webb Street SSS end at a 12-inch box culvert. The 12-inch box culvert could not be observe due to the pasture. The wastewaters flow within a manmade channel and into the MPC.

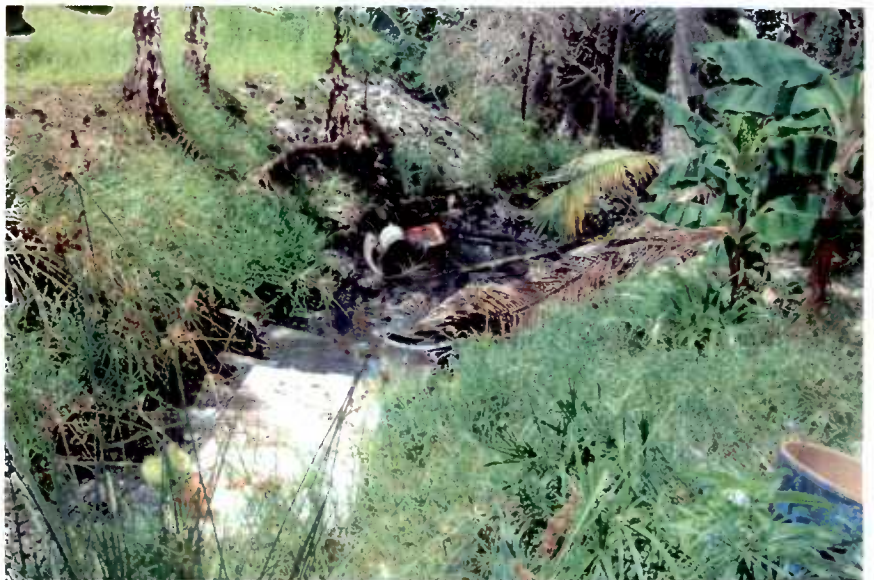
- 6) Wastewaters were observed flowing out of the 12-inch concrete culvert into the manmade channel (e.g., ditch) and into the Martin Peña Channel. See attached Photos No. 3, 4 and 5.

Photo No. 3. View of the wastewaters flowing down in the manmade channel and into the MPC.

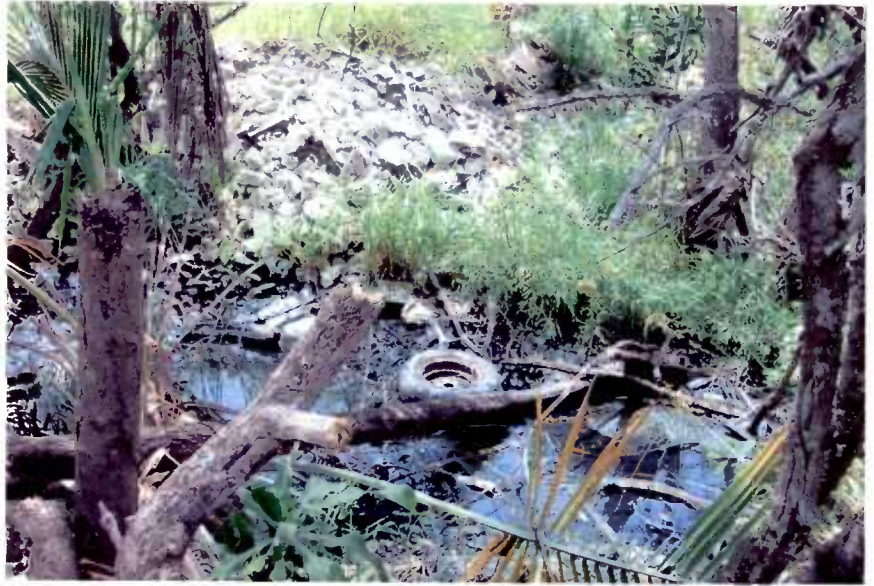
Photo No. 4. Another view of the wastewaters flowing down the manmade channel and into the Martin Peña Channel.

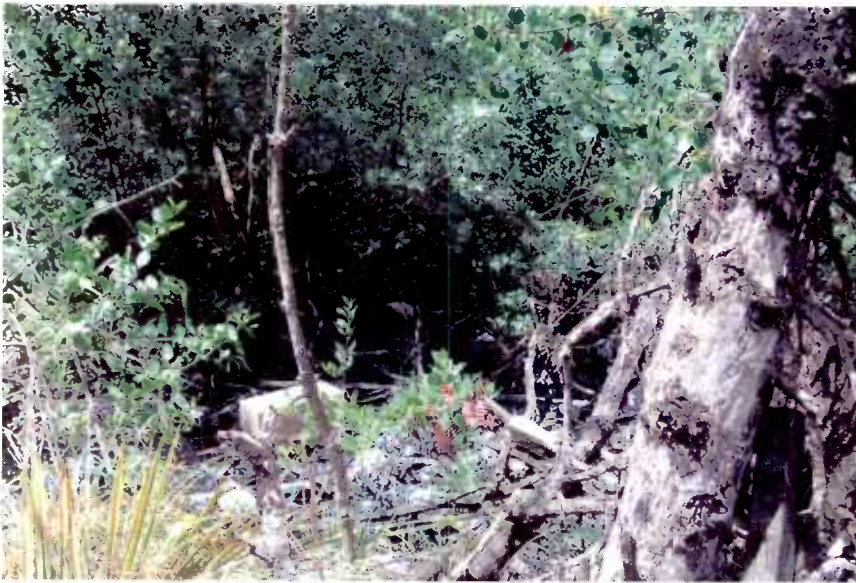
- E) At approximately 11:40 am, the dye mixed with wastewaters entered into the Martin Peña Channel. See attached Photo No. 9.
- 8) Solids of sewage nature were observed at the manmade channel and in the Martin Peña Channel near the end of the manmade channel discharge.

Photo No. 5. Closed view of the end of the manmade channel and Martin Peña Channel.

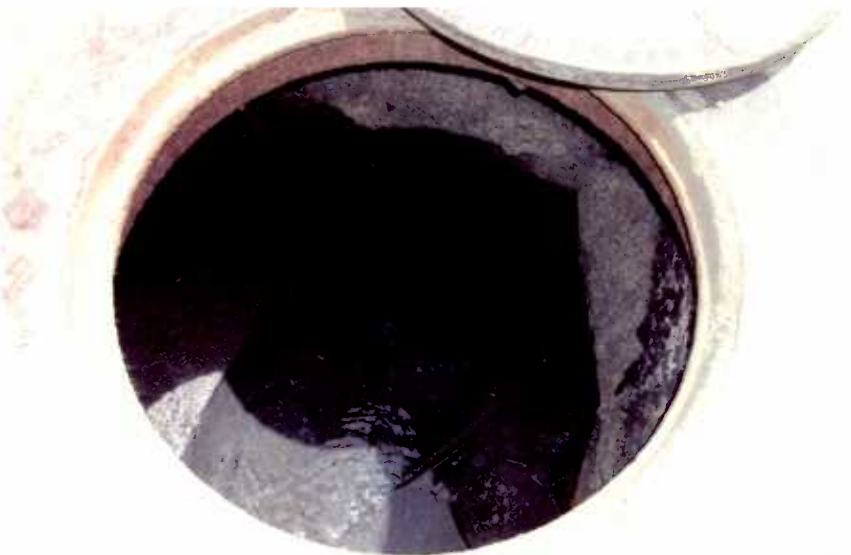
- A) The EPA inspectors' team that participated in this dye test was Mr. Alex Rivera, Mr. Jaime Géliga and Mr. Carlos Villafañe.
 - B) At approximately 11:15 am, the EPA inspectors' team opened a manhole lid located approximately 50 meters from the observed 12 -inch concrete culvert. See attached Photo No. 6.

- C) At approximately 11:20 am, Mr. Jaime Géliga poured approximately ½ liter of green dye into the manhole.
 - D) Approximately at 11:30 am, Mr. Alex Rivera and Mr. Carlos Villafañe, who were standing near the discharge end of the 8-inch pipe and at the 12-inch culvert, observed the dye being discharged from the 12-inch culvert and into the manmade channel. See attached Photos No. 7 and 8.

Photo No. 6. View of a Webb Street Sanitary Sewer System's manhole. The dye was poured at this manhole, which sewer pipelines flows down into the Martin Peña Channel.

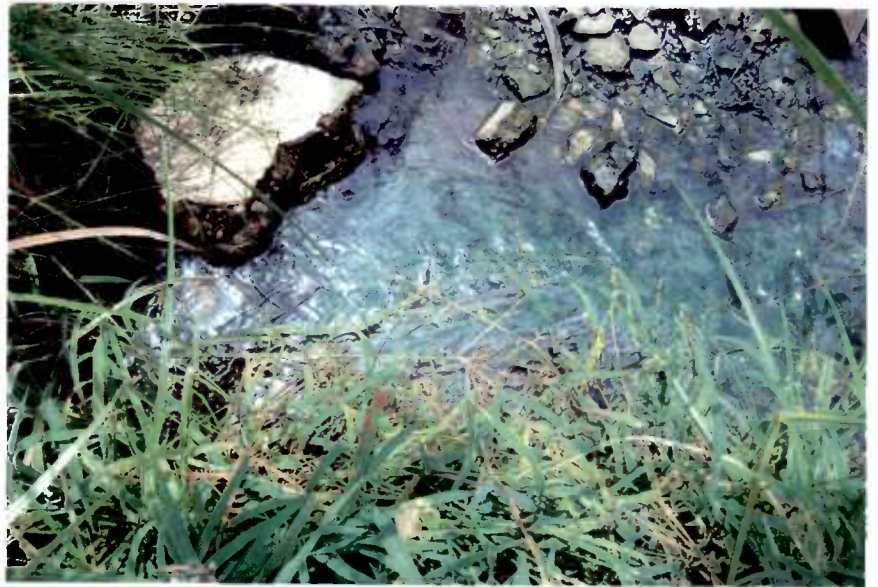
Photo No. 7. View of the dye starting entering into the manmade channel.

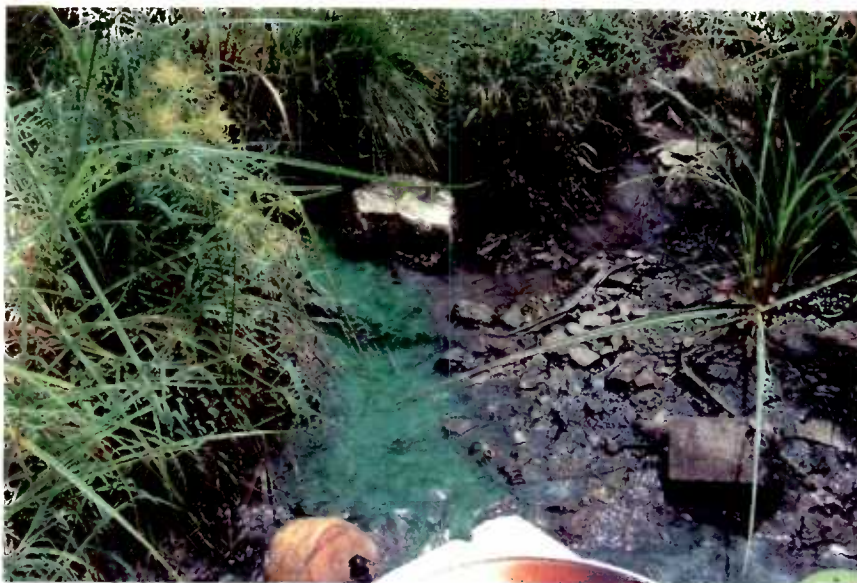
Photo No. 8. Another view of the dye entering into the manmade channel.

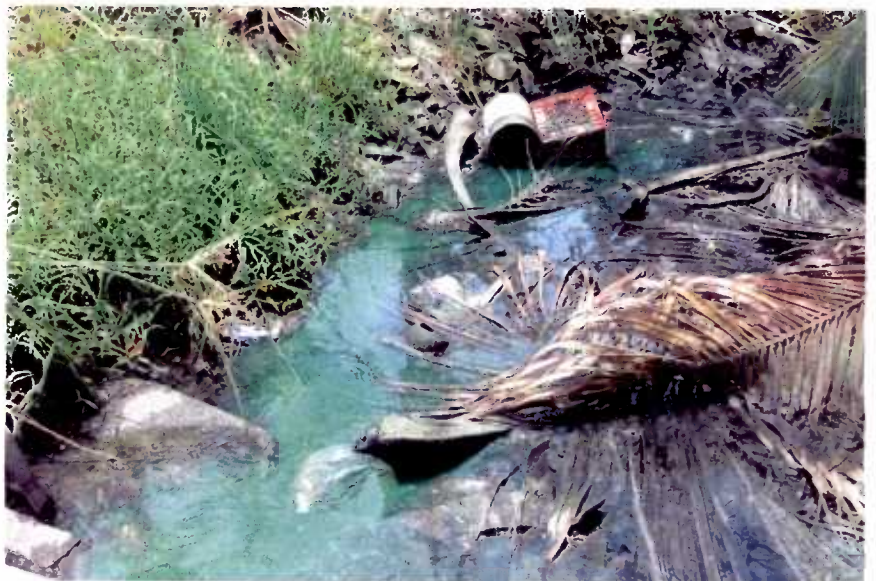
Photo No. 9. Another view of the dye entering into the manmade channel and flowing down into the Martin Peña Channel.
